6.4 MECHANICAL, ELECTRICAL, AND PLUMBING COMPONENTS

6.4.9 LIGHT FIXTURES

6.4.9.3 PENDANT LIGHT FIXTURES

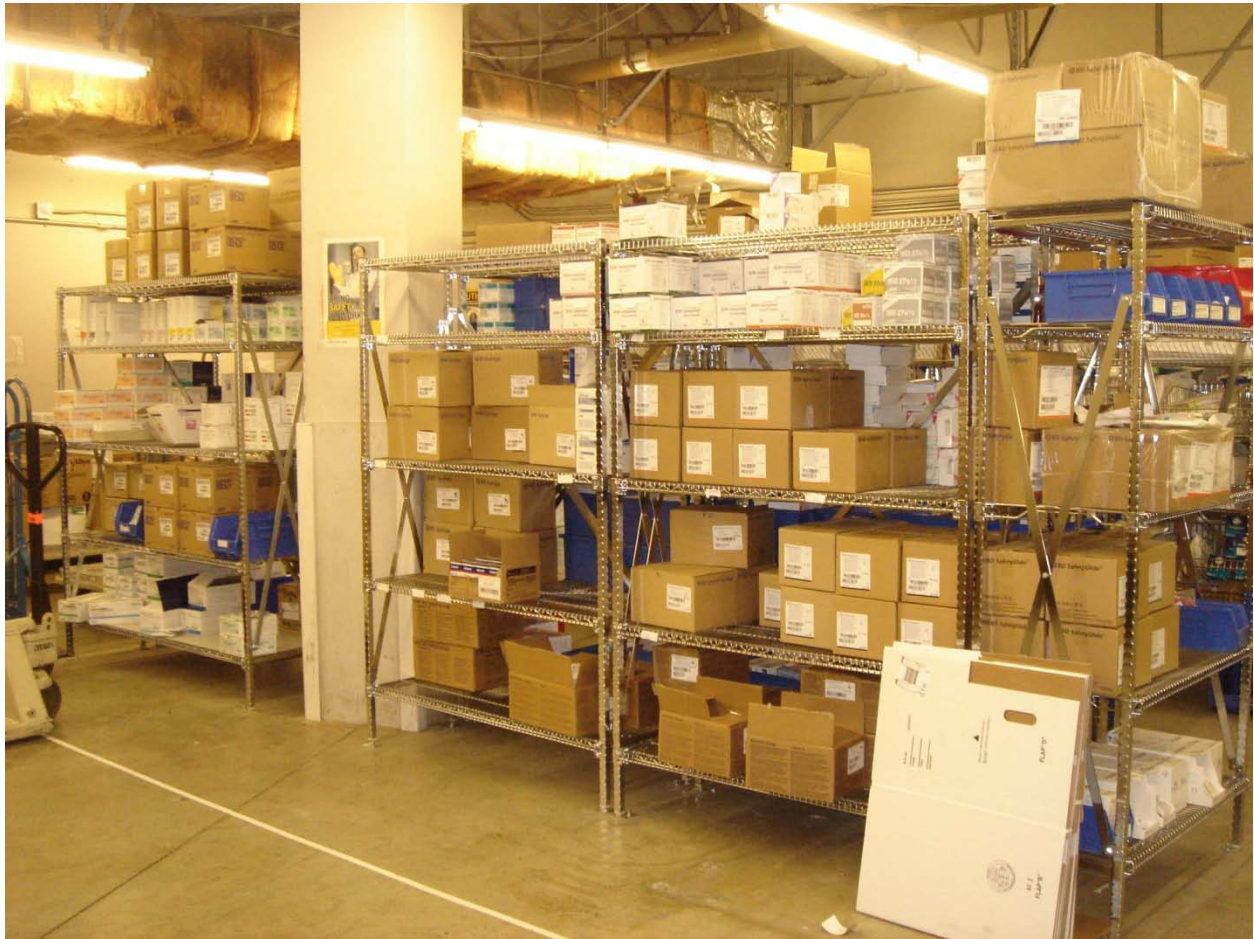
Figure 6.5.1.1-7 Fixed base shelving units anchored directly to concrete slab through base plate (Photo courtesy of Maryann Phipps, Estructure).

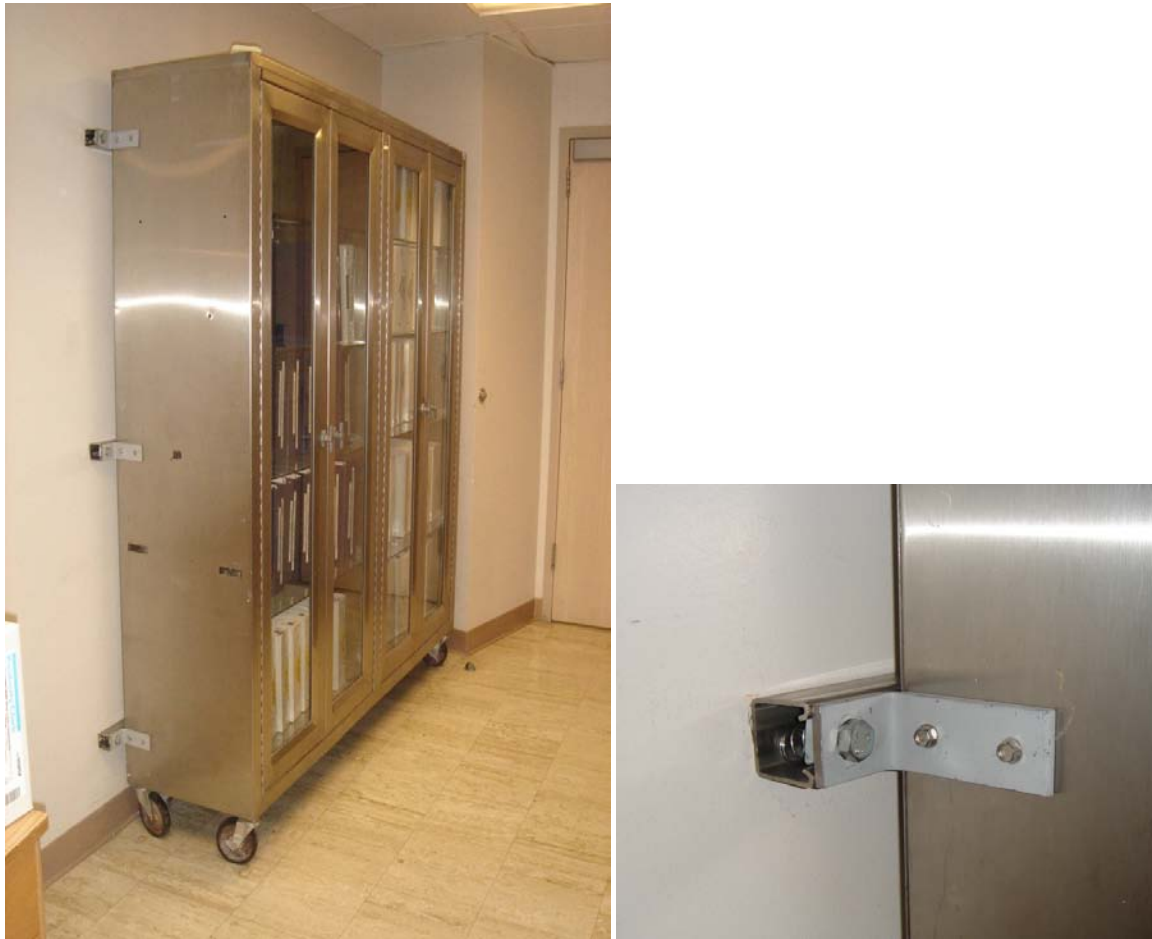
Figure 6.5.1.1-8 Mobile shelving unit restrained by connection to strut fastened to full height metal studs (Photo courtesy of Maryann Phipps, Estructure).

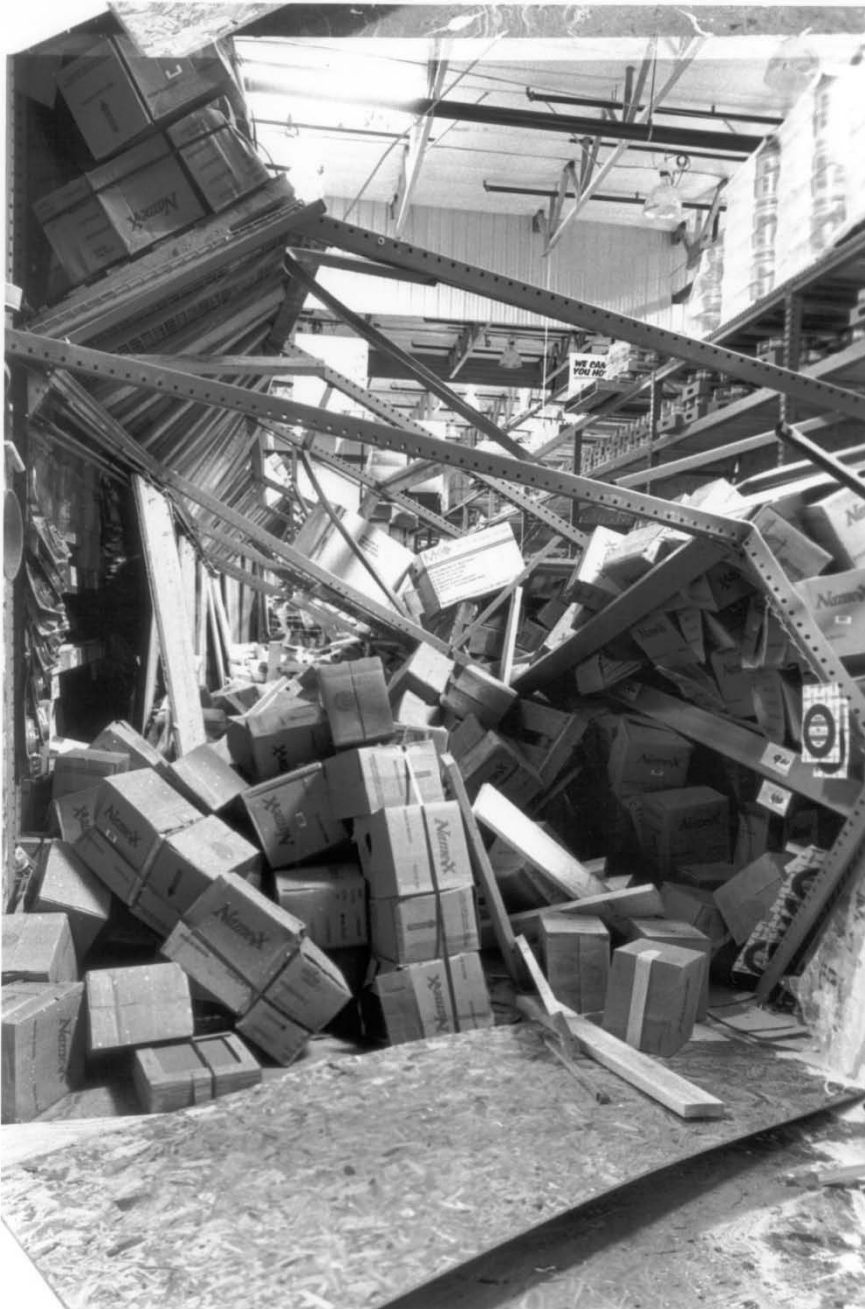
Figure 6.5.1.2-1 Damage to overloaded racks during the 1994 magnitude-6.7 Northridge Earthquake (FEMA 460, 2005).

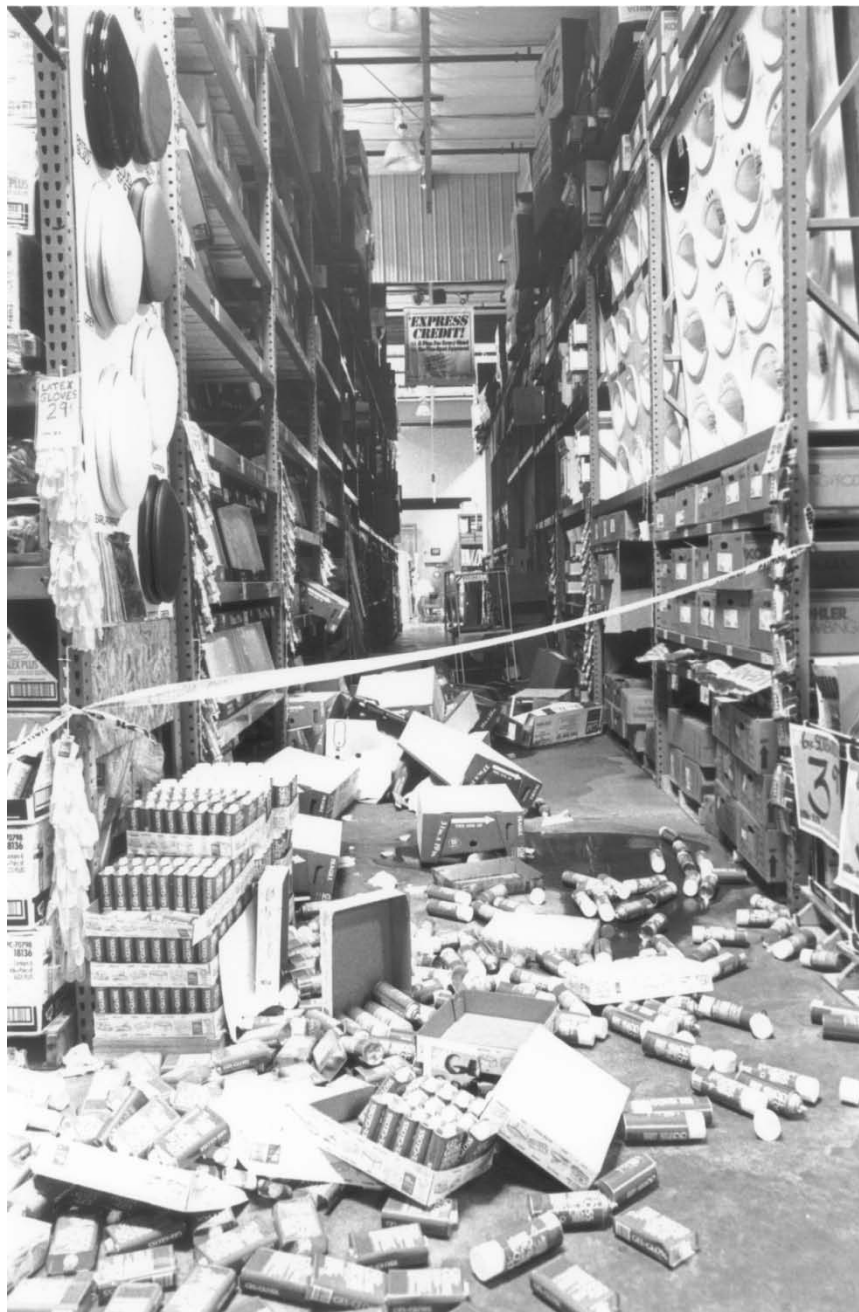
Figure 6.5.1.2-2 Spilled contents during the 1994 Northridge Earthquake (FEMA 460, 2005).

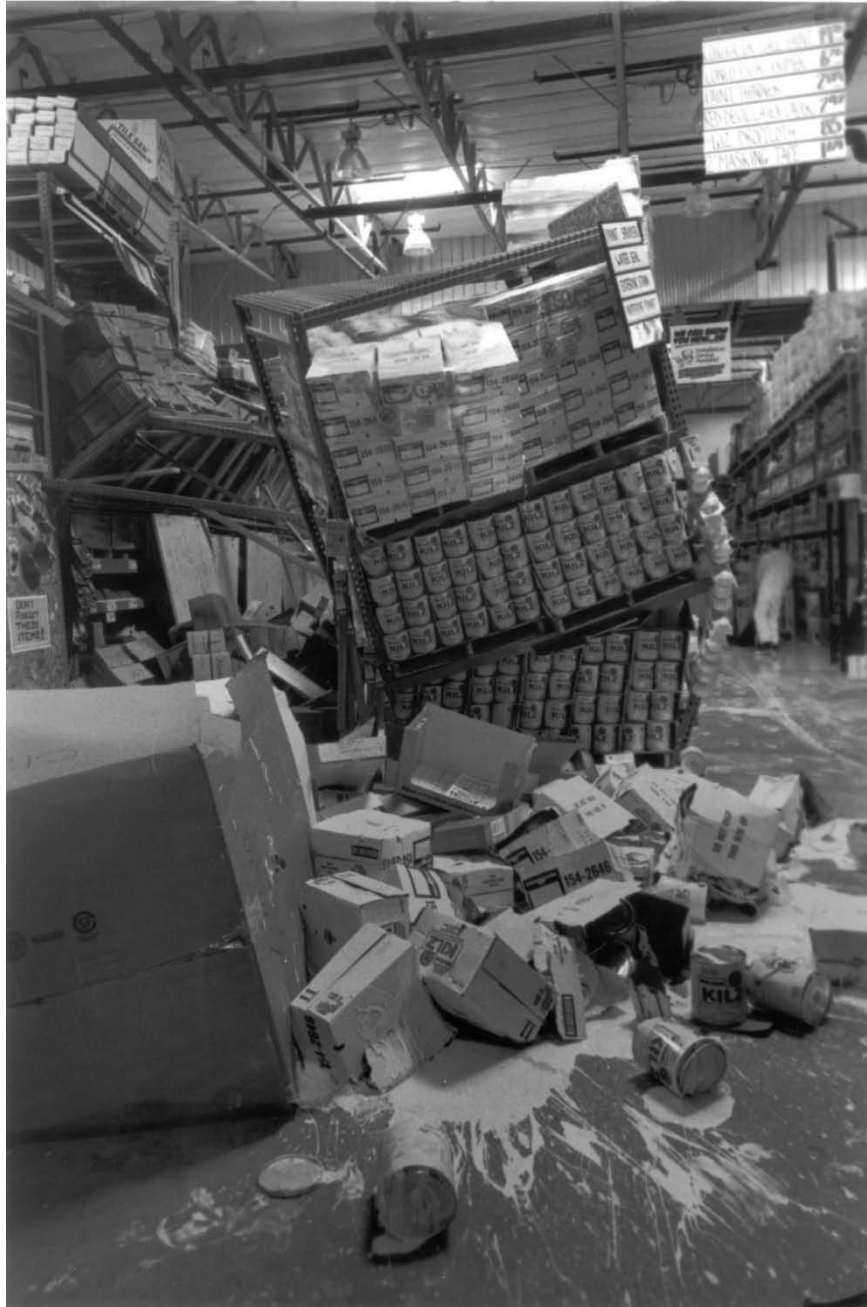
Figure 6.5.1.2-3 Rack collapse during the 1994 Northridge Earthquake. Note the minimal damage to shrink wrapped merchandise (FEMA 460, 2005).

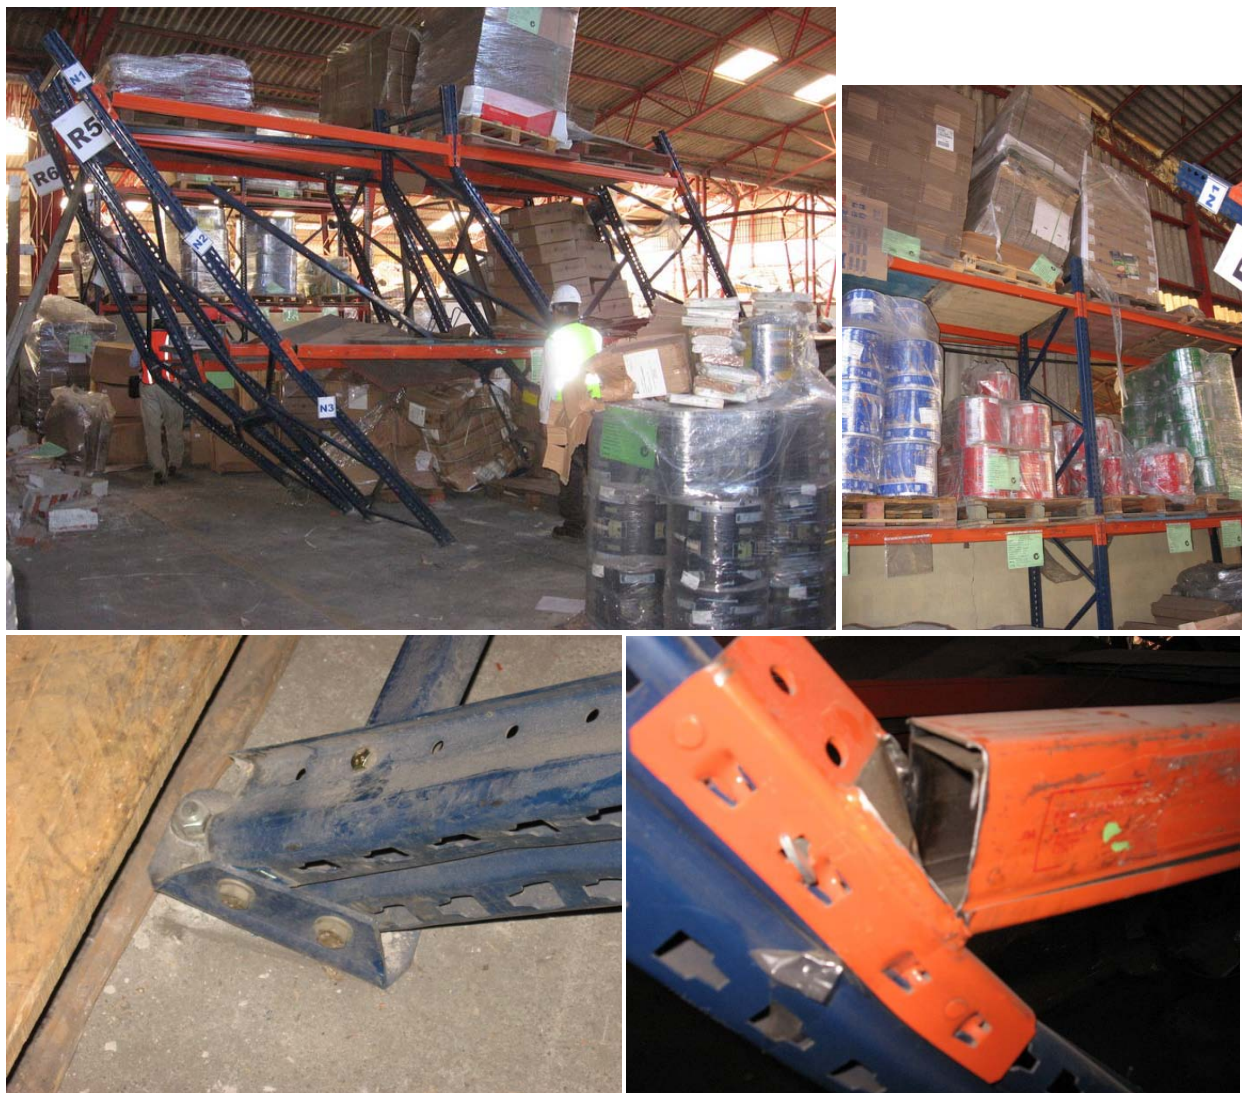
Figure 6.5.1.2-4

Failure of anchored racks in the 2010 magnitude-8.8 Chile Earthquake. The racks are leaning precariously due to inadequate bracing in the longitudinal direction and weak connections between the components. The welded fitting at the end of the beam failed at the weld in many places. Note that most items were shrink wrapped so merchandise did not scatter (Photos courtesy of Rodrigo Retamales, Rubén Borosc hek & Associates).

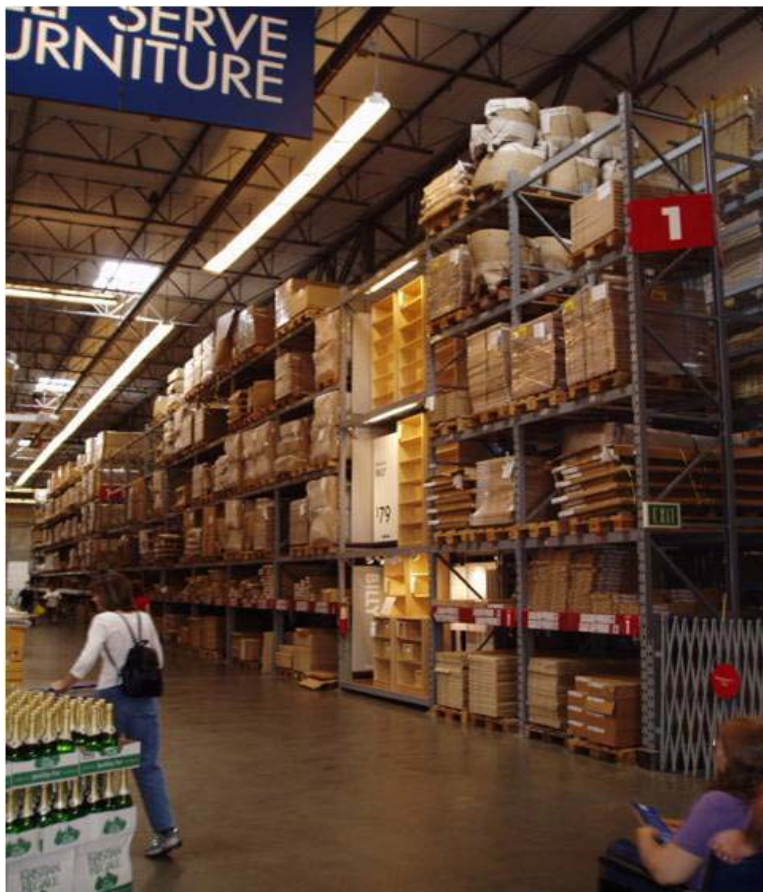
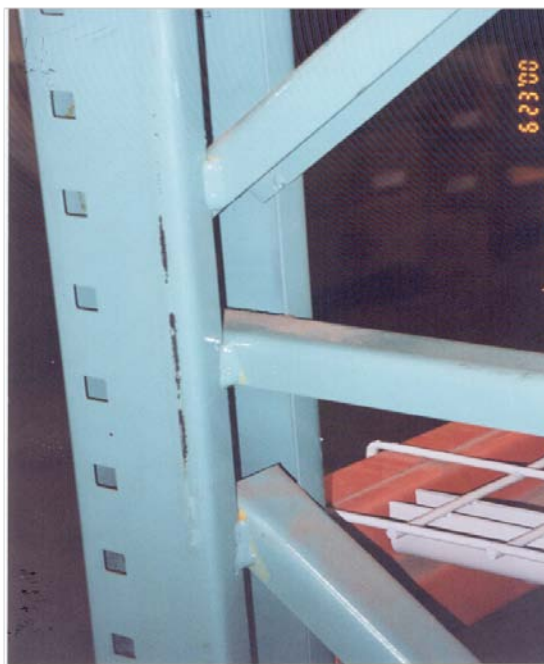
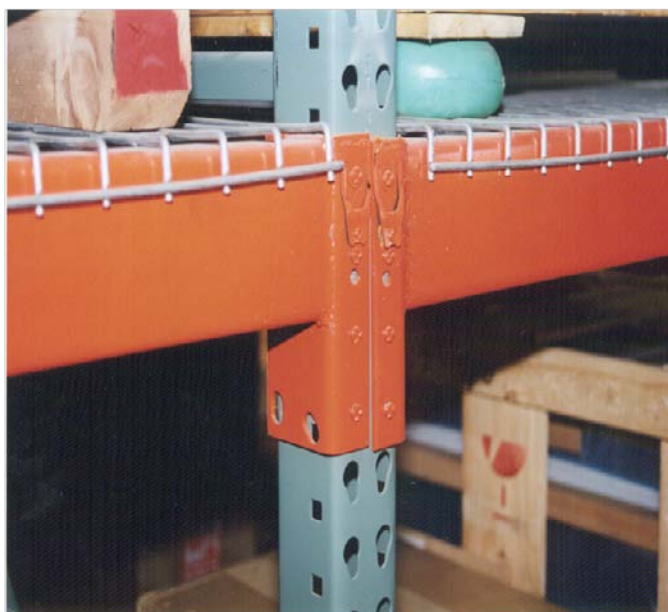
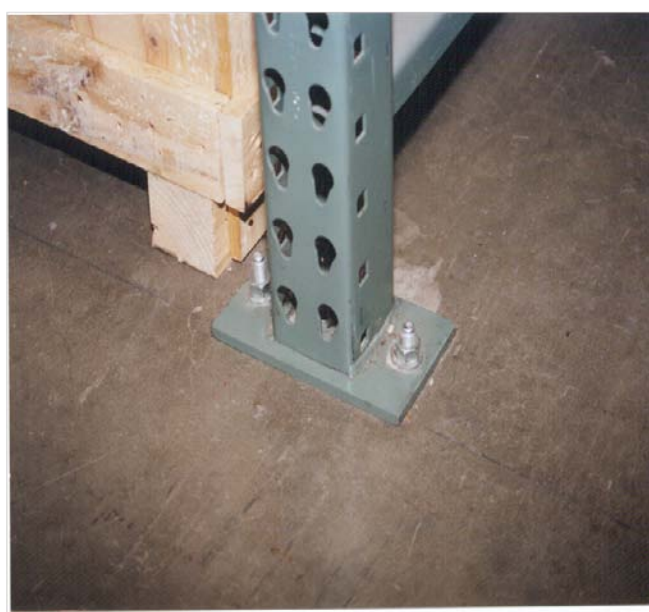
Figure 6.5.1.2-5 Typical pallet storage rack configuration and details (Photos courtesy of Maryann Phipps, Estructure).

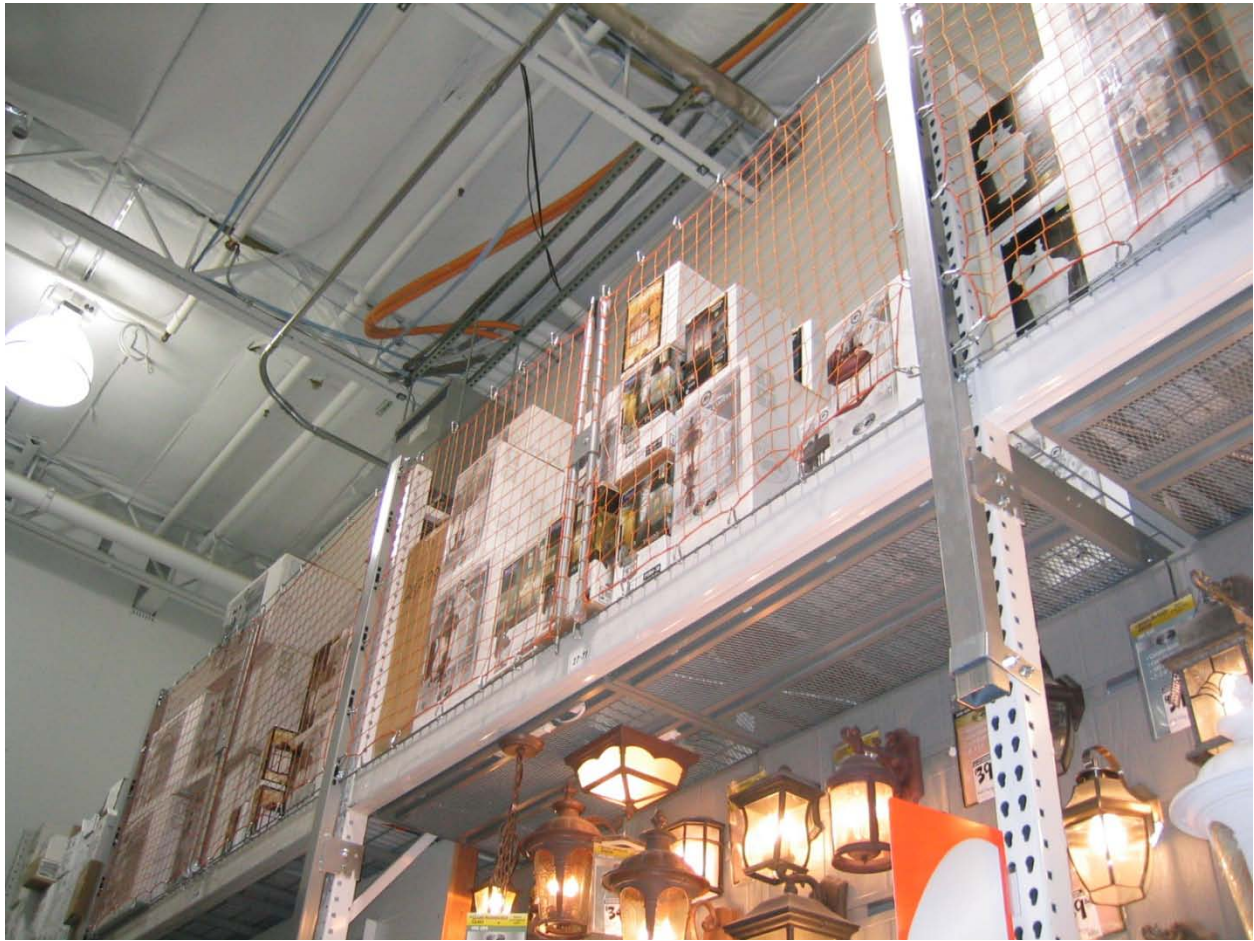
Figure 6.5.1.2-6 Photo showing netting used to keep storage on upper portions of steel storage racks in a big box hardware store (Photo courtesy of Mike Mahoney, FEMA).
